Manhole Inspection Summary

Manhole # S41AA_069MH

Inspection ☐ Is Incomplete Rating: **3) Fair**

Location Address: **722 wharton ct**

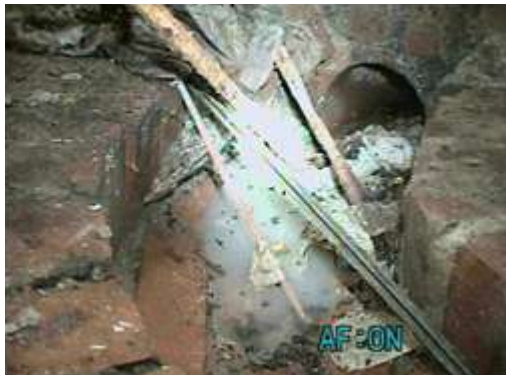
Defect 4

Condition: ☐ Sound ☐ Cracked ☐ Root Intrusion ☐ Deteriorated ☐ Leaks ☒ **Debris**

channel debris

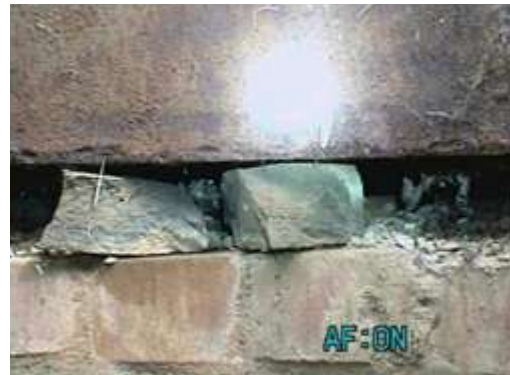
Defect 2

Condition: ☐ Sound ☒ **Cracked** ☐ Root Intrusion ☒ **Loose Brick** ☒ **Deteriorated**

chimney cracked, loose bricks, & deteriorated

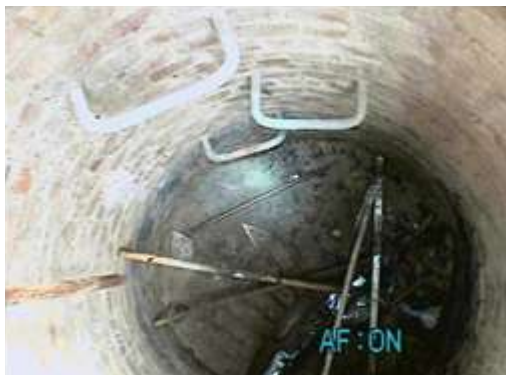
Defect 1

Condition: ☐ Sound ☐ Cracked ☐ Root Intrusion ☐ Deteriorated ☐ Leaks ☒ **Debris**

Steps Count: **3** Missing: **0** ☒ **Corroded**

corroded steps, bench debris

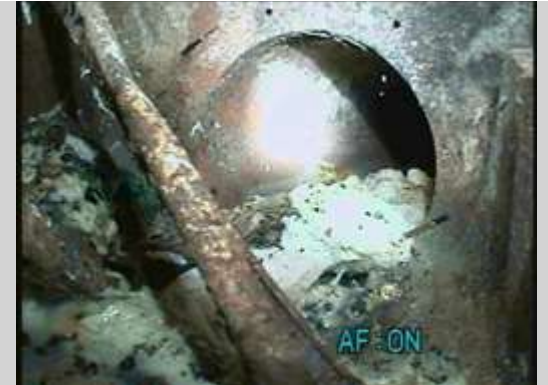
12 O'Clock Outflow

8 in. Circular Gravity Sewer
Pipe Out @ 12 O'Clock

Deposits: ☐ None ☐ Mud ☐ Sludge ☒ **Debris** ☐ Grease

Silt Depth: 3 (in.) Deposits Extent: **Light**
